PROJECT LARKSPUR

AMCHITKA ISLAND, ALASKA

INVESTIGATIONS OF
AREAS 1, 2, 3 AND 4
Sanitized Version

US ARMY ENGINEER DISTRICT, ALASKA

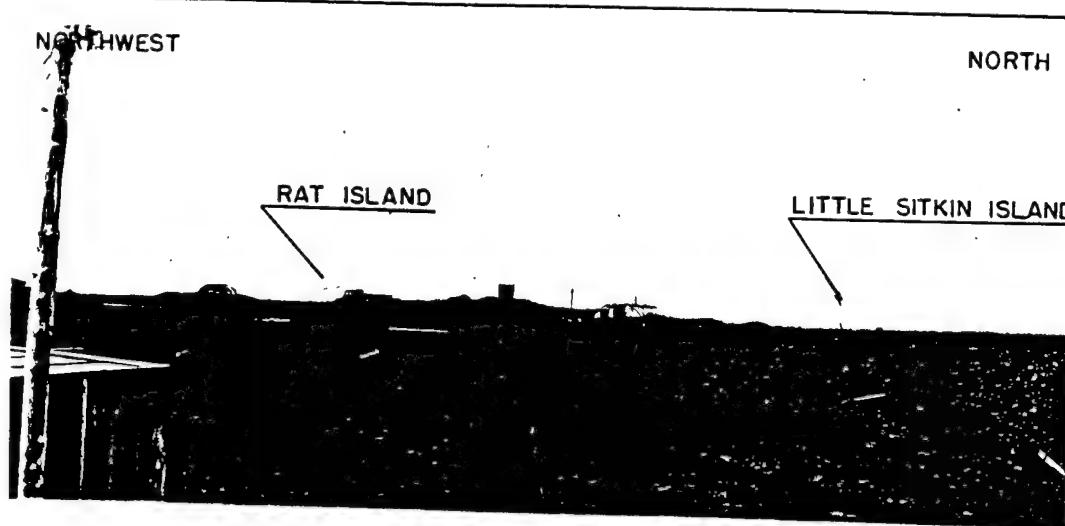
PHOTO # 1. PANORAMIC VIEW NW, FROM MAP COORDINATES 145208.
ABANDONED MILITARY CAMP NEAR NW END OF ISLAND.

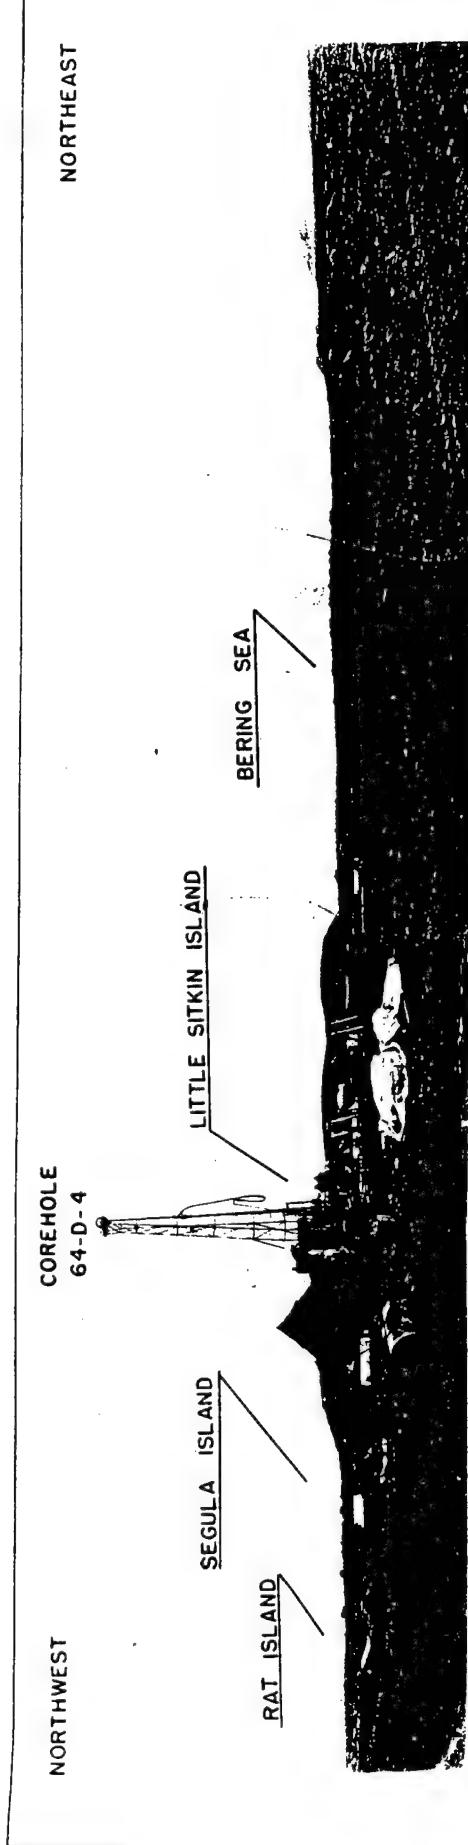
PHOTO # 2. PANORAMIC VIEW NORTH FROM MAP COORDINATES 174203
AREA 1, CORE DRILL RIG AND SURROUNDING TERRAIN.

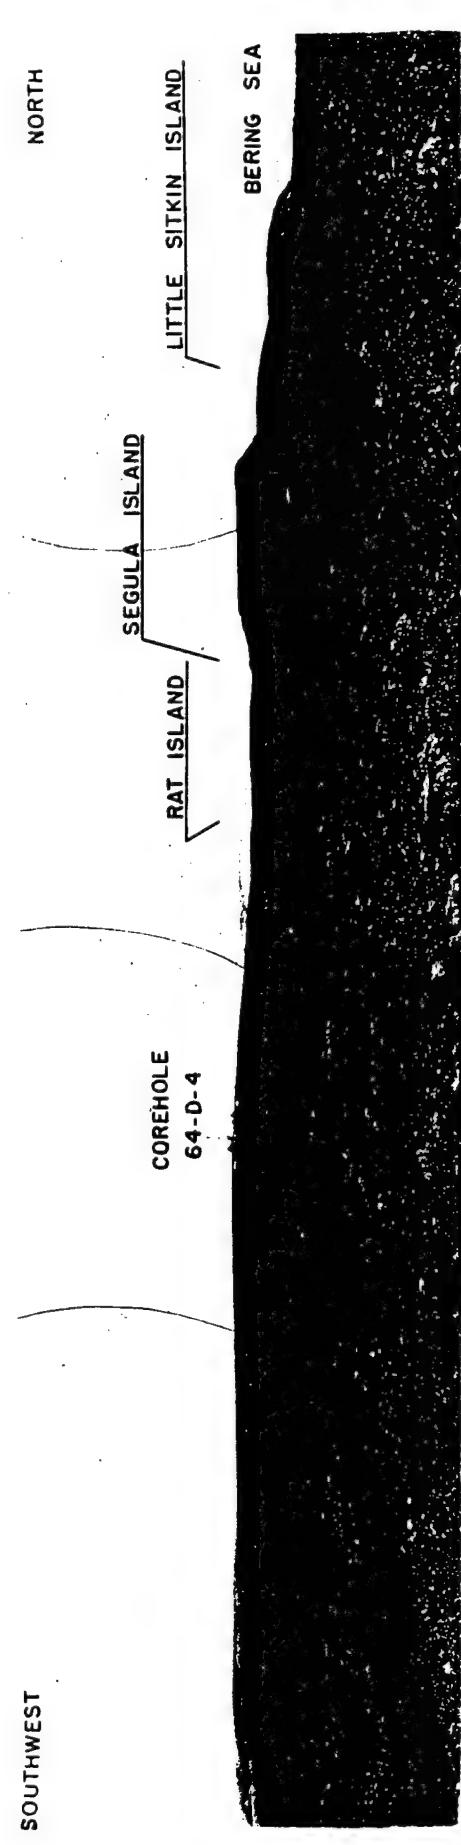
PHOTO # 3. PANORAMIC VIEW NORTHWEST FROM MAP COORDINATES 178202.
FLAT UPLAND RIDGE IN AREA 1.

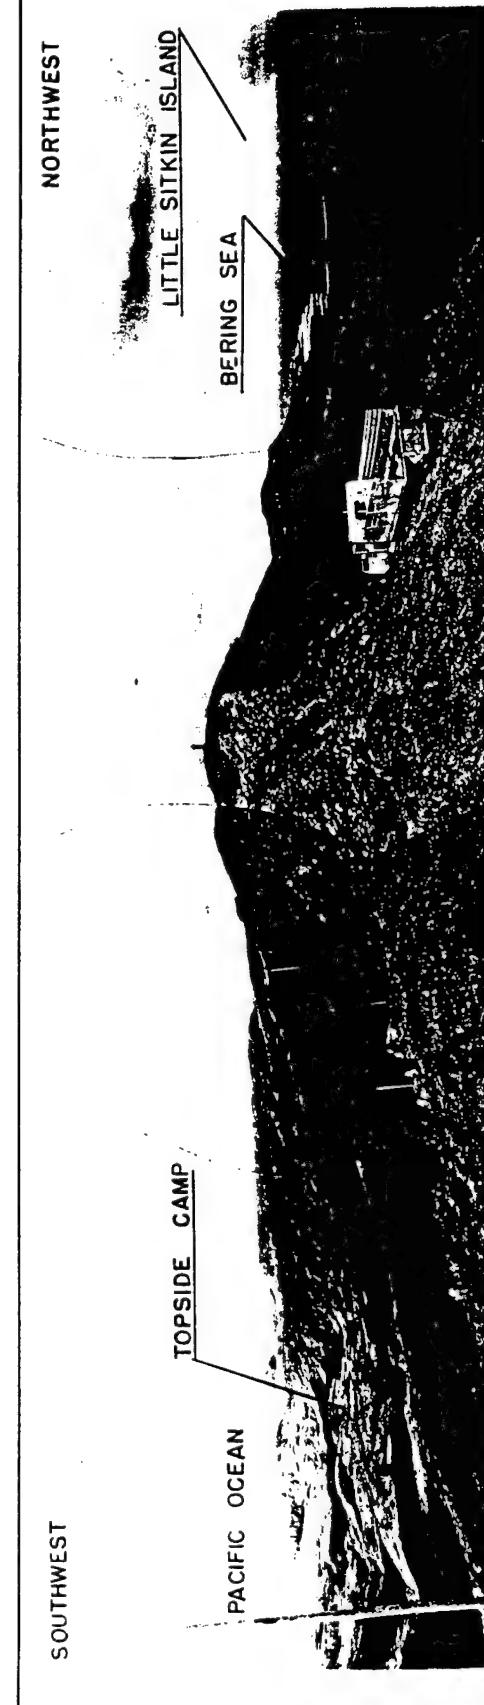
PHOTO # 6. PANORAMIC VIEW FROM MAP COORDINATES 2911.82.
HILLY TERRAIN ALONG OLD MILITARY ROAD.

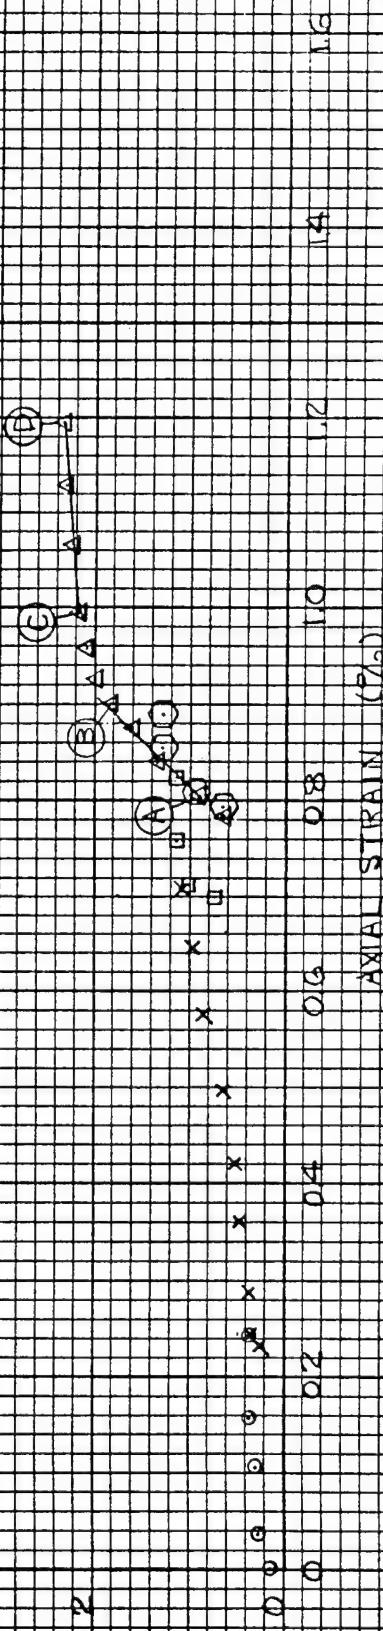
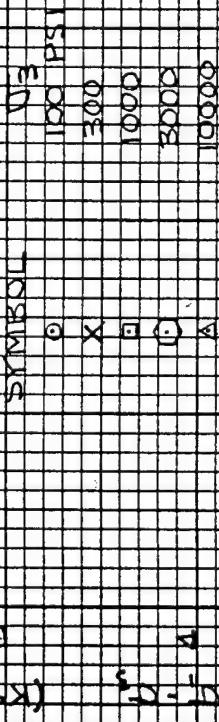
FIGURE 6

$\sigma_3 = 10,000$ PSI
SPECIMEN TESTED S.S.D.
CONDITION PRIOR TO TEST: SOUND
CONDITION AFTER TEST: APPARENTLY
UNCHANGED

TEST WAS RUN TO POINT ③ ? A
LEAK DEVELOPED IN THE HYDRAULIC
SYSTEM, THE SYSTEM WAS DIS-
ASSEMBLED AND REPAIRED, AND
THE TEST RE-RUN. ON THE
SECOND RUN A LEAK DEVELOPED
IN THE HYDRAULIC SYSTEM WHEN
SAMPLE STRAIN REACHED 0.29%
AND THE TEST WAS TERMINATED
